STRADBROKE HEALTH CENTRE  
ASBESTOS REPORT 7<sup>th</sup> June 2021

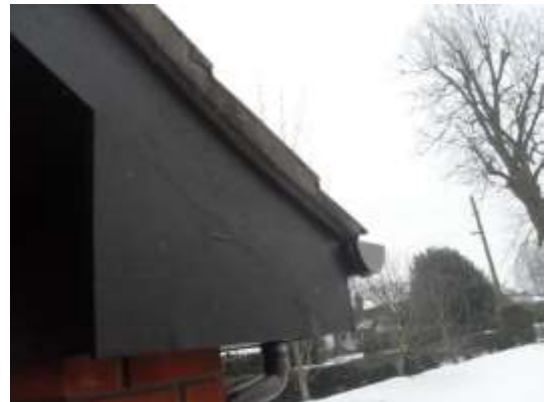
A detailed survey undertaken in 2010 highlighted that chrysotile was present in the cement under cloaking of the roof.

The risk was identified as low – 6.

There has been no deterioration in the material.

<b>Area Title</b>	External
<b>Floor/Level</b>	Ground Floor
<b>Product Type</b>	Cement Products
<b>Item Description</b>	S17
<b>Estimated Extent</b>	40 m
<b>Labelled</b>	No
<b>Product Description</b>	Cement under cloaking

<b>Product Type</b>	Cement Products	1	<b>Material Factor</b>	<b>Potential For Fibre Release</b>
<b>Treatment</b>	None	3	<b>&gt;= 10</b>	High
<b>Damage Extent</b>	Low	1	<b>7 - 9</b>	Medium
<b>Asbestos Type</b>	Chrysotile	1	<b>5 - 6</b>	Low
<b>Material Factor Rating</b>		<b>6</b>	<b>0 - 4</b>	Very Low

The condition of the under cloaking is monitored regularly.
