## Type II Asbestos Survey

# Fressingfield Medical Centre

Survey Reference Number: **MSC/10/0008**

Stradbroke Medical Centre  
Wilby Road  
Stradbroke  
Nr Eye Suffolk IP21 5JN

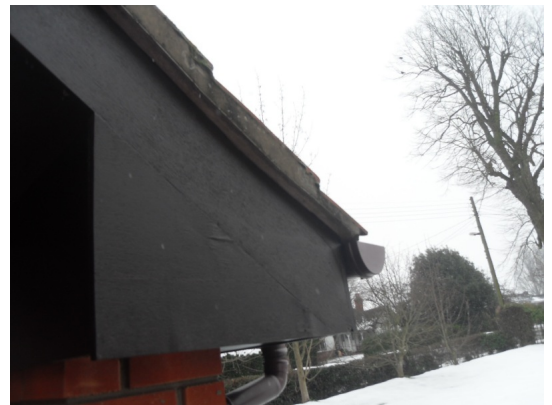
<b>Area Title</b>	External
<b>Floor/Level</b>	Ground Floor
<b>Product Type</b>	Cement Products
<b>Item Description</b>	S17
<b>Estimated Extent</b>	40 m
<b>Labelled</b>	No
<b>Product Description</b>	Cement under cloaking

<b>Product Type</b>	Cement Products	1	<b>Material Factor</b>	<b>Potential For Fibre Release</b>
<b>Treatment</b>	None	3	<b>&gt;= 10</b>	High
<b>Damage Extent</b>	Low	1	<b>7 - 9</b>	Medium
<b>Asbestos Type</b>	Chrysotile	1	<b>5 - 6</b>	Low
<b>Material Factor Rating</b>		<b>6</b>	<b>0 - 4</b>	Very Low

<b>Material Factor Rating</b>	Result from Material Assessment (above)	6
<b>Material Category</b>	Potential for fibre release	Low
<b>HSE Notifiable</b>	Yes / No	No

**6 The area should be subjected to a full environmental clean by an appropriately qualified contractor.**
